Project No. 752019

February 4, 2020

Subject: Canaan Elementary School Roof

SSE 01/10/20 INSPECTION PHOTOS

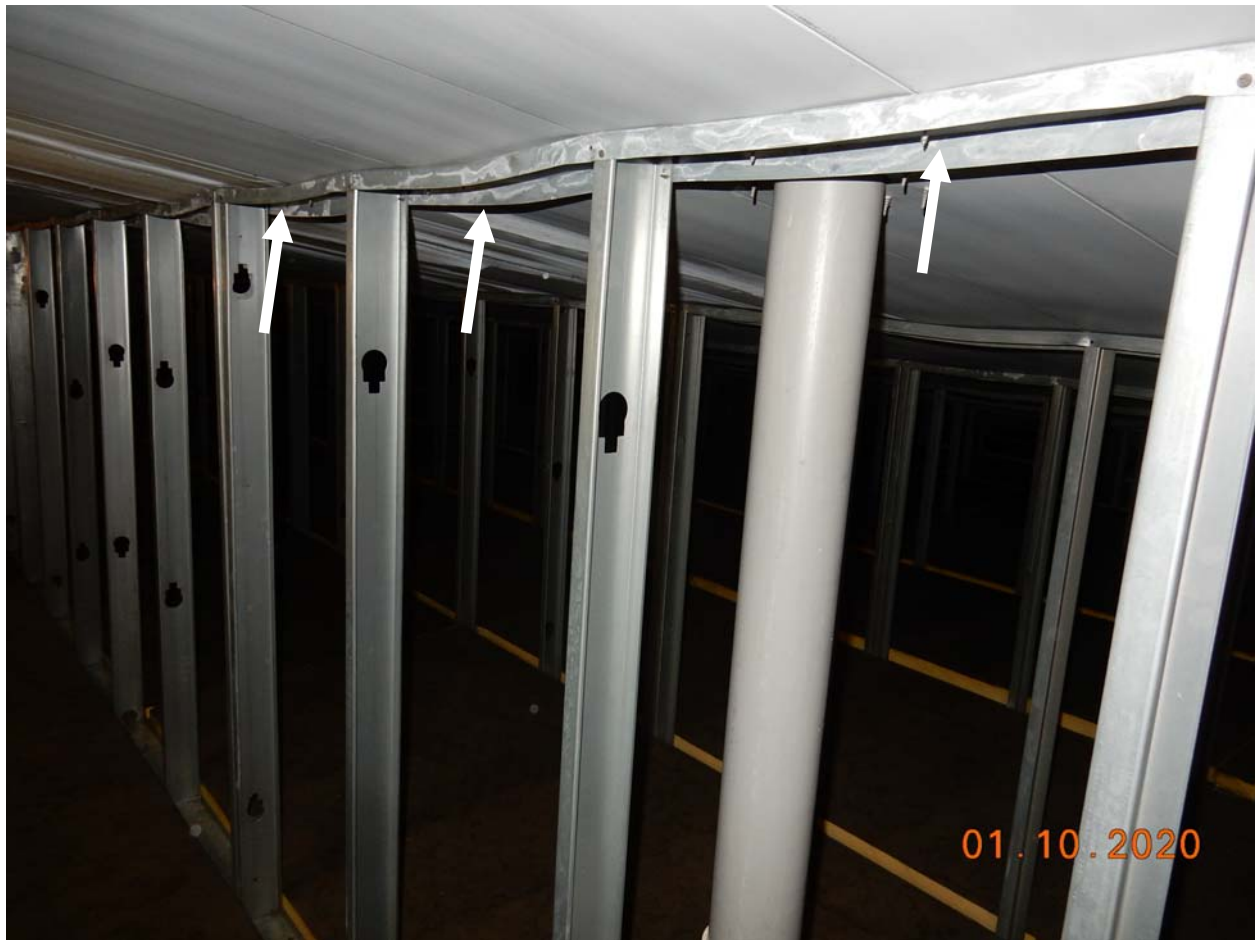
Upon inspection of the school's attic space above the classrooms, it was apparent that the 2004 roof modifications had significant problems in the southeast quadrant of that section of the building. In the southeast quadrant, I found that the rows of cold formed steel studs had only a track (also called a "runner") section at the top of the studs, and that those track sections had buckled flanges which were significantly deformed, with the tracks sagging by as much as $\frac{3}{4}$ " (estimated) between the studs. A very quick review of other nearby areas in the classroom attic revealed that the stud rows there had tracks that were reinforced with a strongback, an additional cold formed steel member. Where the reinforcement was present (reportedly the majority of the attic space above the classrooms), the tracks were not noticeably deformed or buckled. I have appended an excerpt from drawing # 2 of the 1960 architectural plans, showing the floor plan for the building. On that excerpt, I have hatched the currently known problematic area in pink, to identify its location. That area is about 36' wide east-west by about 50' long north-south. The area encompasses attic space from the current ridgeline eastward to the east eave, and from the south end of the classroom wing 50' northward to about the mid length of the wing.

Where the top tracks were found deformed in the southeast quadrant of the attic, the standing seam roofing had generally followed suit, and was similarly found sagging between the studs in each row. I observed some of the studs, and found them undeformed and undamaged. The standing seam roofing is attached to the top of the unreinforced tracks with clips which are screwed to the tracks. As is typical of standing seam roofing, the vertical legs of the clips are contained within the standing seams of the roofing, thereby concealing the clips from view. Such roofing is also referred to as a concealed fastener system, for that reason. In many instances observed, the standing seam roofing, although sagging, was found to have small and varying gaps between its underside and the top of the sagging track. This condition suggests that the roof has experienced heavier snow loads in the past, causing the track to deflect below the current sagging position of the standing seam roofing.

Looking northeast in attic space in southeast quadrant of school, above classroom wing. Track (arrows) at top of light gage cold formed studs is unreinforced and deformed.

We consequently discussed possible reinforcement of the deformed tracks. It was suggested that the deformed tracks could be forced back into a straighter and less deformed geometry, and a new strongback added directly under the roofing and attached to the undamaged steel studs, mimicking what had been done in 2004 elsewhere in the attic. I pointed out that although the standing seam roofing was reportedly not problematic regarding leaks, that trying to force the roofing back into a straighter geometry with the tracks (because the roofing is attached to the tracks) might create leaks or other problems with that roofing. I emphasized that the sags in the roofing could not be straightened out independent of the sagging tracks, because the roofing is attached (screwed) to the tracks via the concealed clips mentioned earlier in this report. I also pointed out that the outwardly buckled flanges of the tracks, as well as the screws attaching those tracks to the existing studs, would interfere with attempting to locate a new strongback tight up against the underside of the roofing. We consequently discussed a scheme where the new strongback would be located below the track flanges, and a continuous but varying thickness shim installed on top of the strongback, to provide continuous bearing for the curved and deformed profile of the standing seam roofing. I suggested that a cement grout or possibly an epoxy product could be used as the shim, to provide for the required variable thickness. I further opined that while such a remediation scheme could likely be made to be structurally adequate, that removal and replacement of the roofing and damaged tracks would be the best solution. You asked me to look into both options, as the R&R option would likely be costly, and

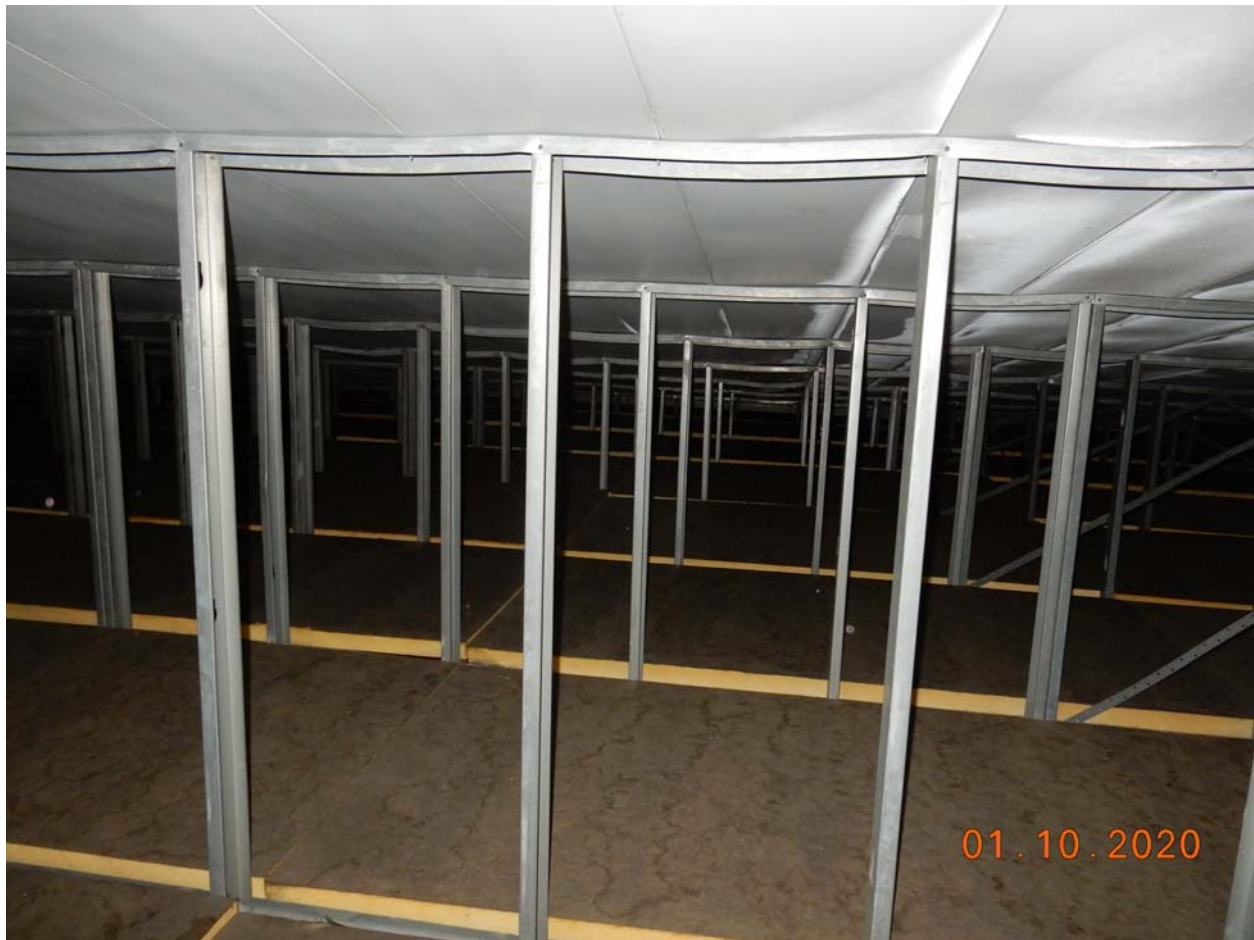
Looking east in attic space in southeast quadrant of school, above classroom wing. Tracks at top of light gage cold formed stud walls are unreinforced and deformed.

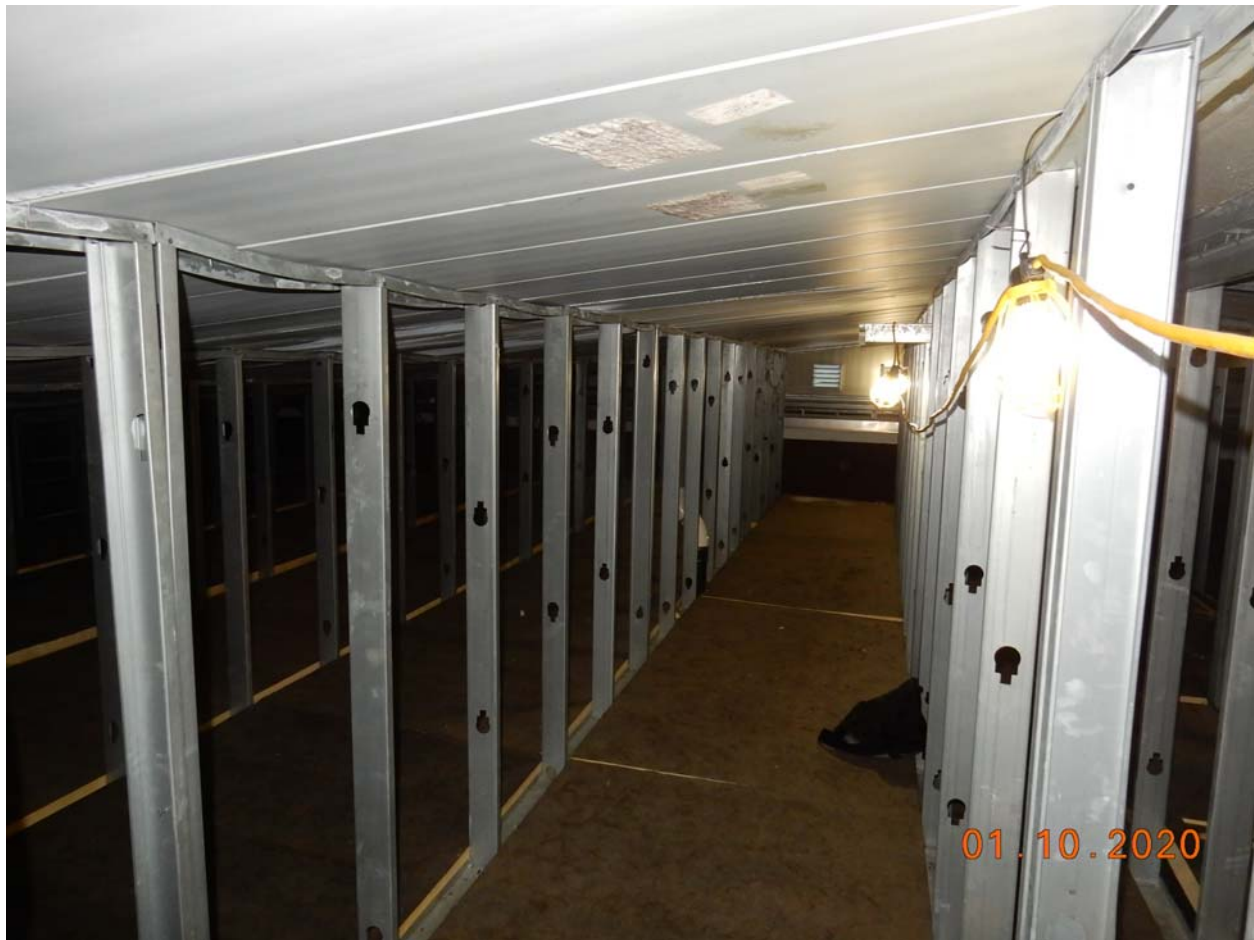
Looking south in attic space in southeast quadrant of school, above classroom wing. Tracks at top of light gage cold formed stud walls are unreinforced and deformed.

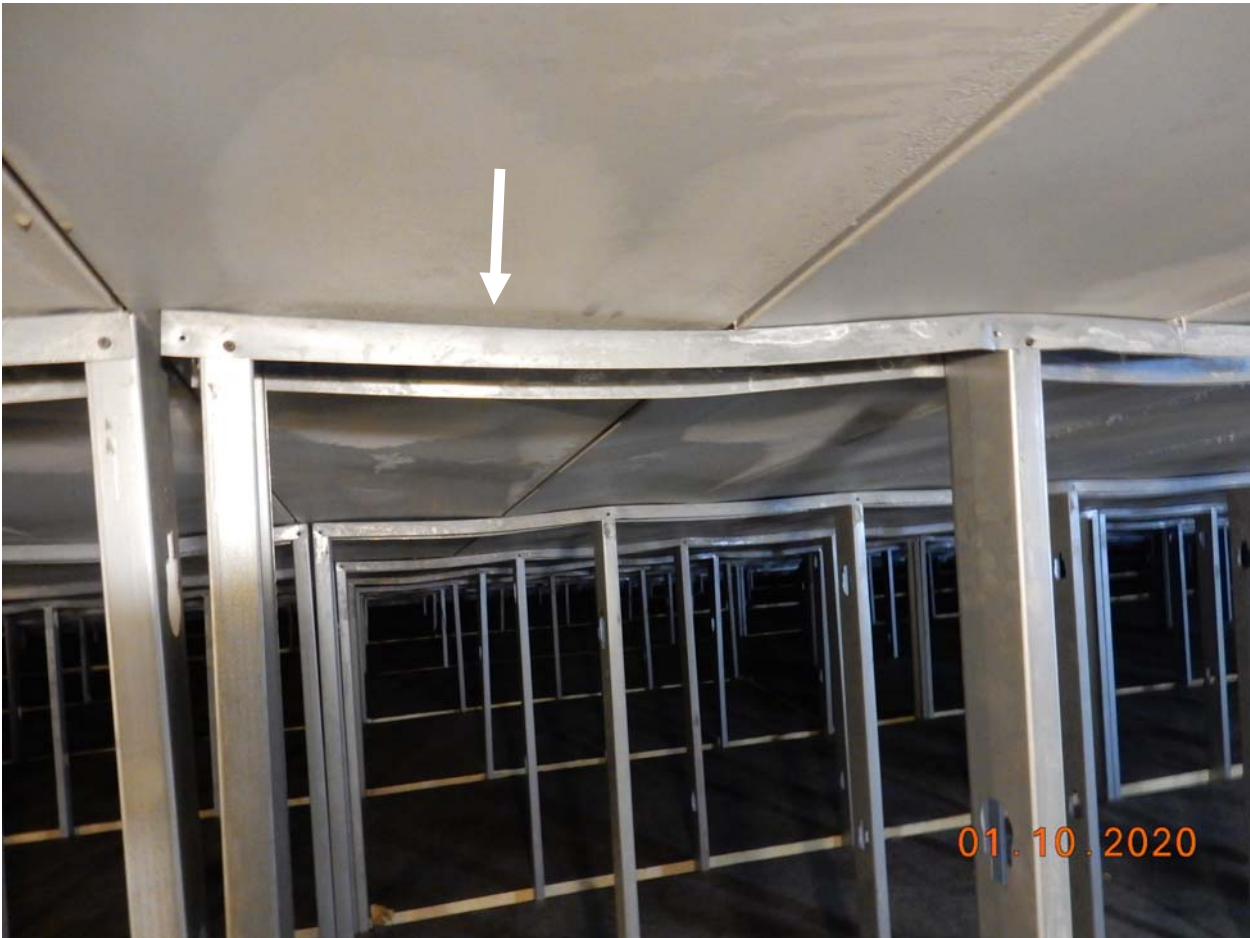
Also while in the attic, we discussed possible repairs for the problematic cold formed steel framing in the southeast quadrant of the classroom wing. I pointed out that the deformed and sagging track sections over the top of the steel studs had not only sagged, but that the flanges of the tracks had also buckled. Buckling of steel is an inelastic and permanent deformation (damage). As such, a buckled steel framing member, whether heavy structural steel or light gage cold formed steel like the deformed tracks, cannot be structurally reconstituted by straightening. Replacement or reinforcement are generally the only two viable options for dealing with buckled members. We discussed that removing and replacing (R&R) the damaged track sections would require removal and replacement of the existing standing seam roofing in the affected area. I asked if that roofing was known to have any leaks or other problems, and was told it did not.

Closer view of deformed tracks at top of studs. Note gap (arrow) between underside of standing seam roofing and top of track.

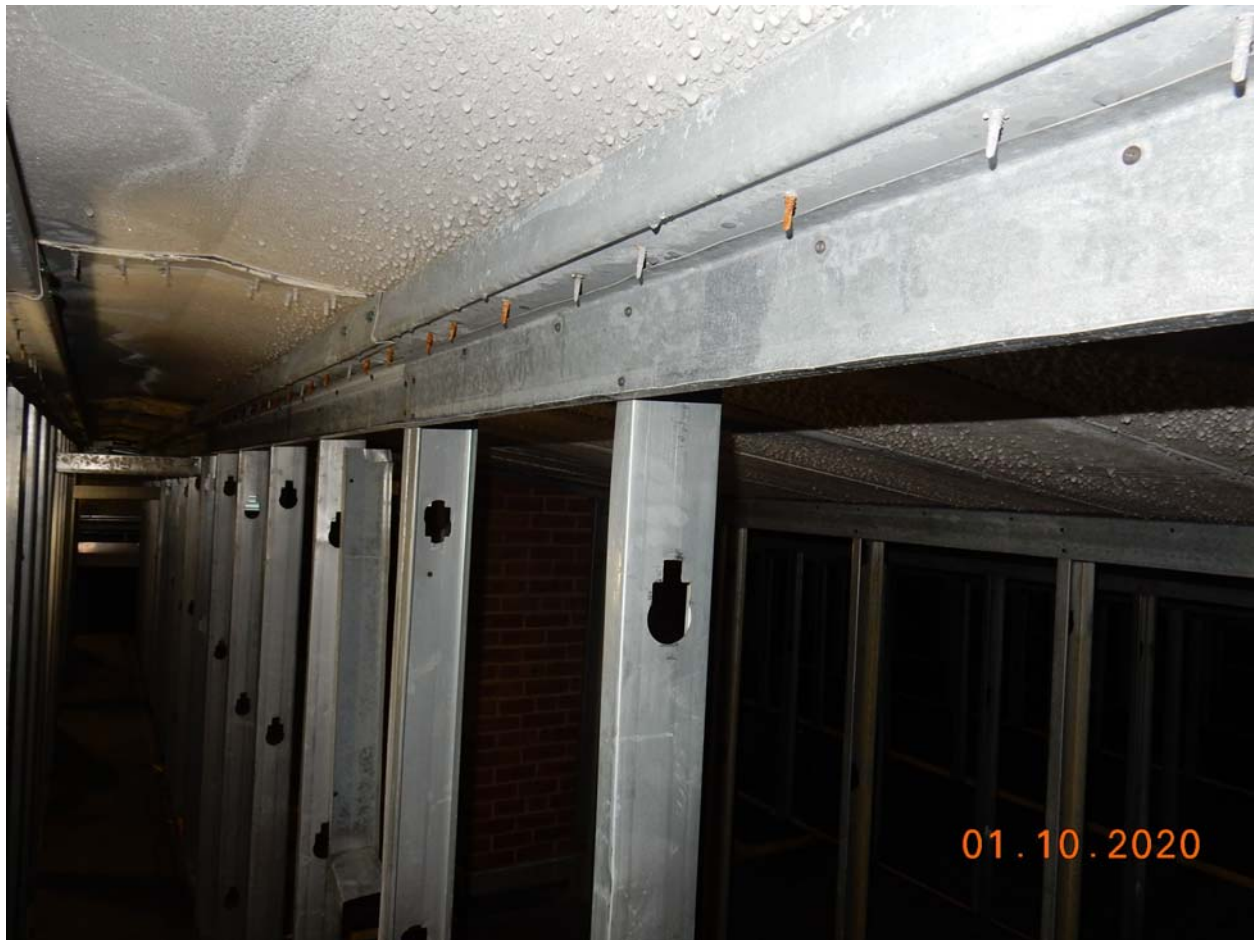
While on site, I made it clear that the sagging and buckled top track on the steel stud walls in the southeast quadrant of the classroom wing of the building represent a structural problem and deficiency. However, based on my observations, this condition did not appear to represent an imminent threat, but is serious, and does merit regular periodic observation by knowledgeable school personnel for changes, until repairs can be made. Because the standing seam roofing is applied directly on top of the steel stud walls, without benefit of any underlayment, sheathing, or insulation, condensation was present on the underside of the standing seam roofing. I asked if the moisture thus generated created any problems in the attic or classrooms below, and was told it did not.

Looking south in attic space near south end of classroom wing, directly under ridge cap. Rows of studs at right are in southwest quadrant of attic and are reinforced with strongback (another track section). Note condensation on underside of ridge cap and standing seam roofing to right.

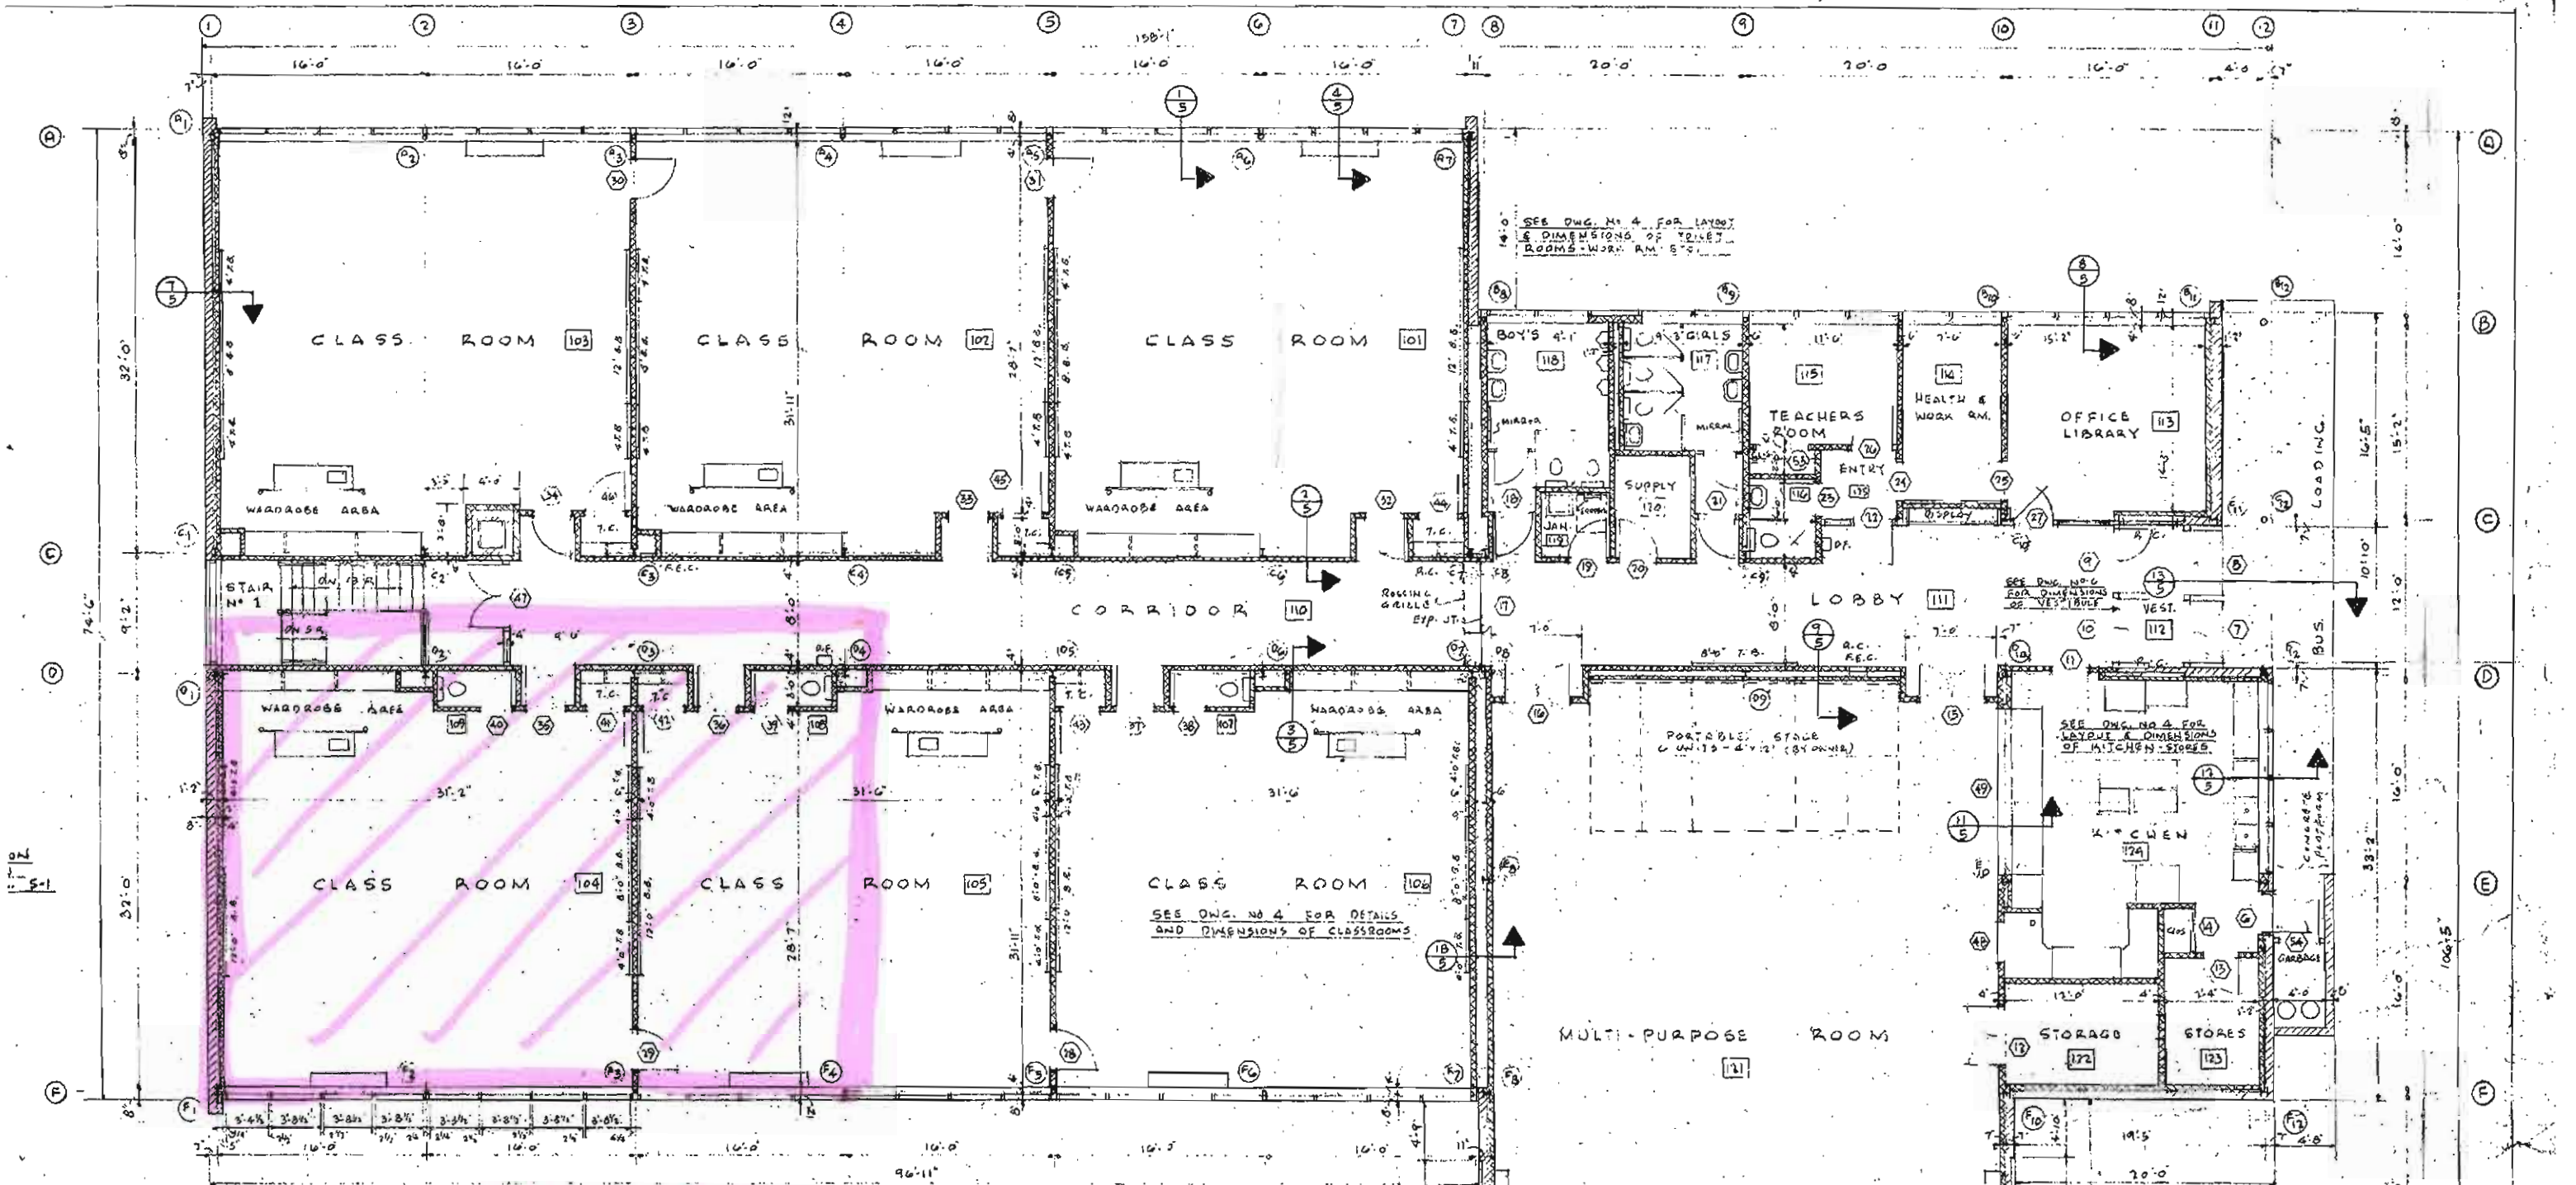
**EXCERPT FROM 1960 BUILDING PLANS SHOWING
CURRENTLY KNOWN PROBLEM AREA HATCHED**

PROBLEM AREA
 236' x 50'

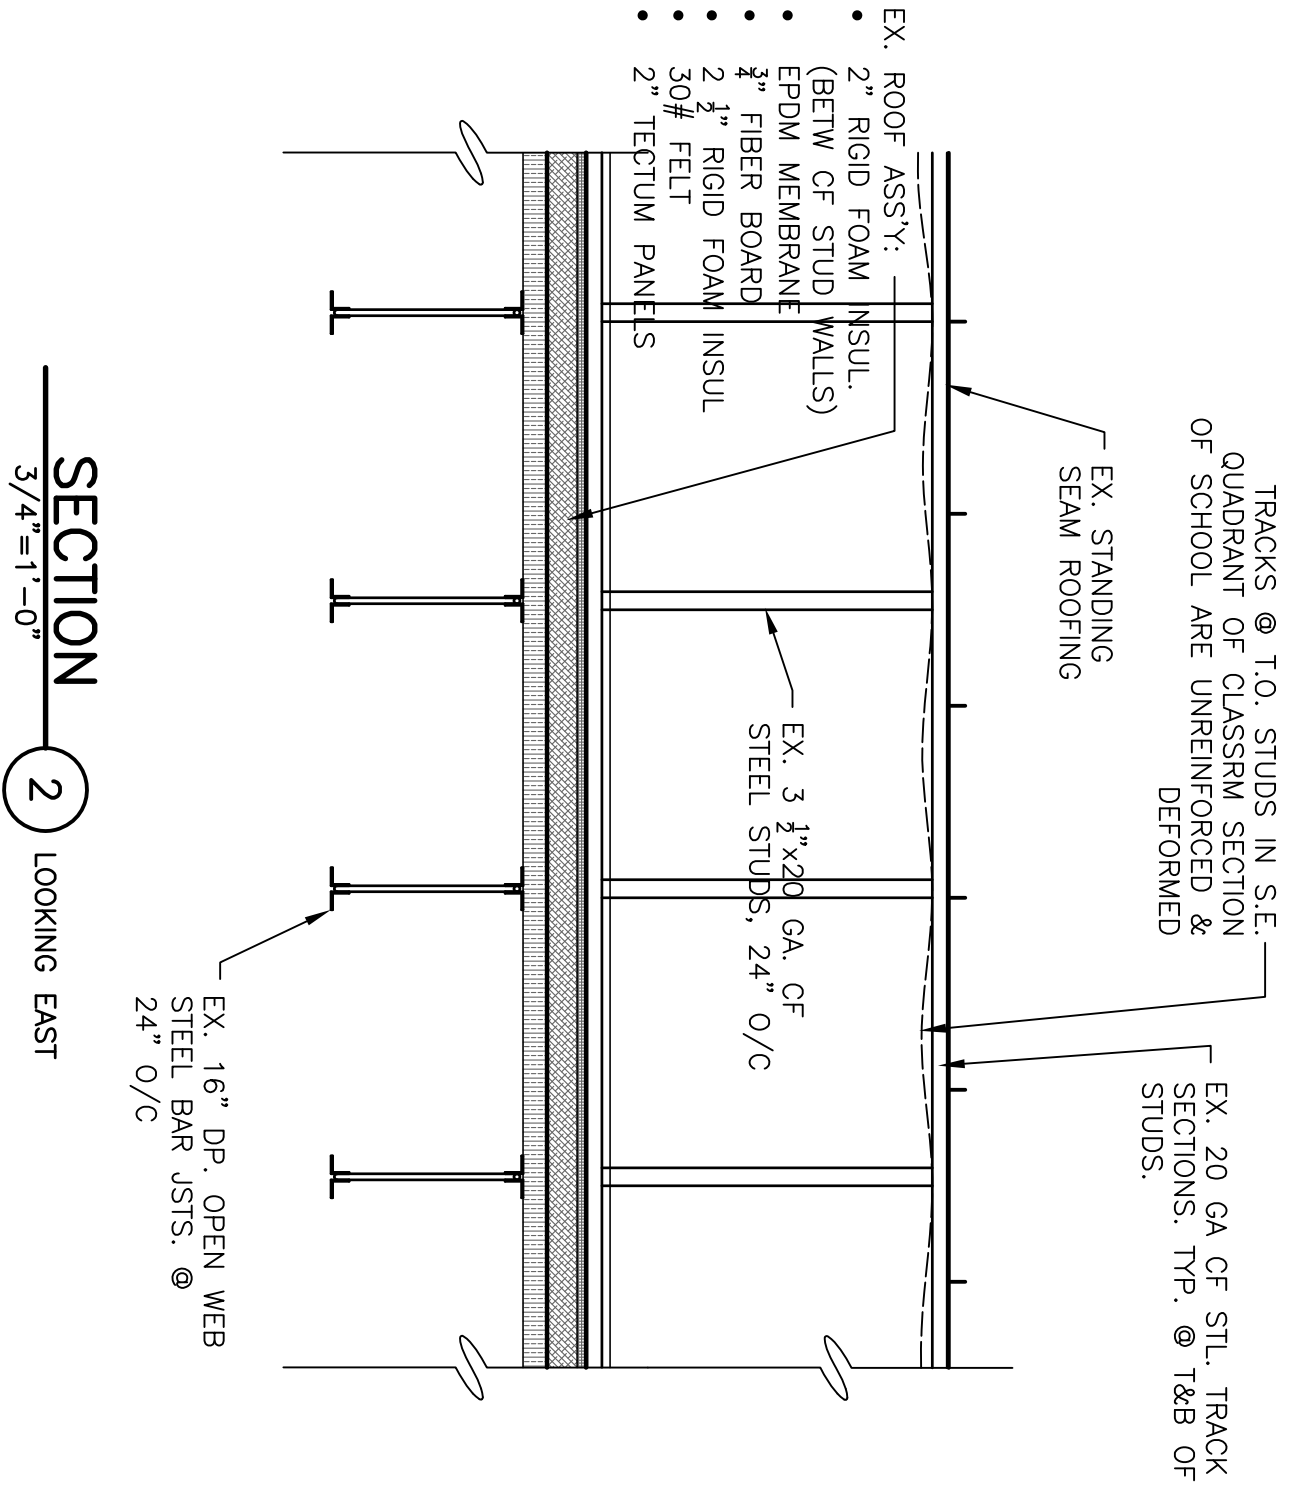
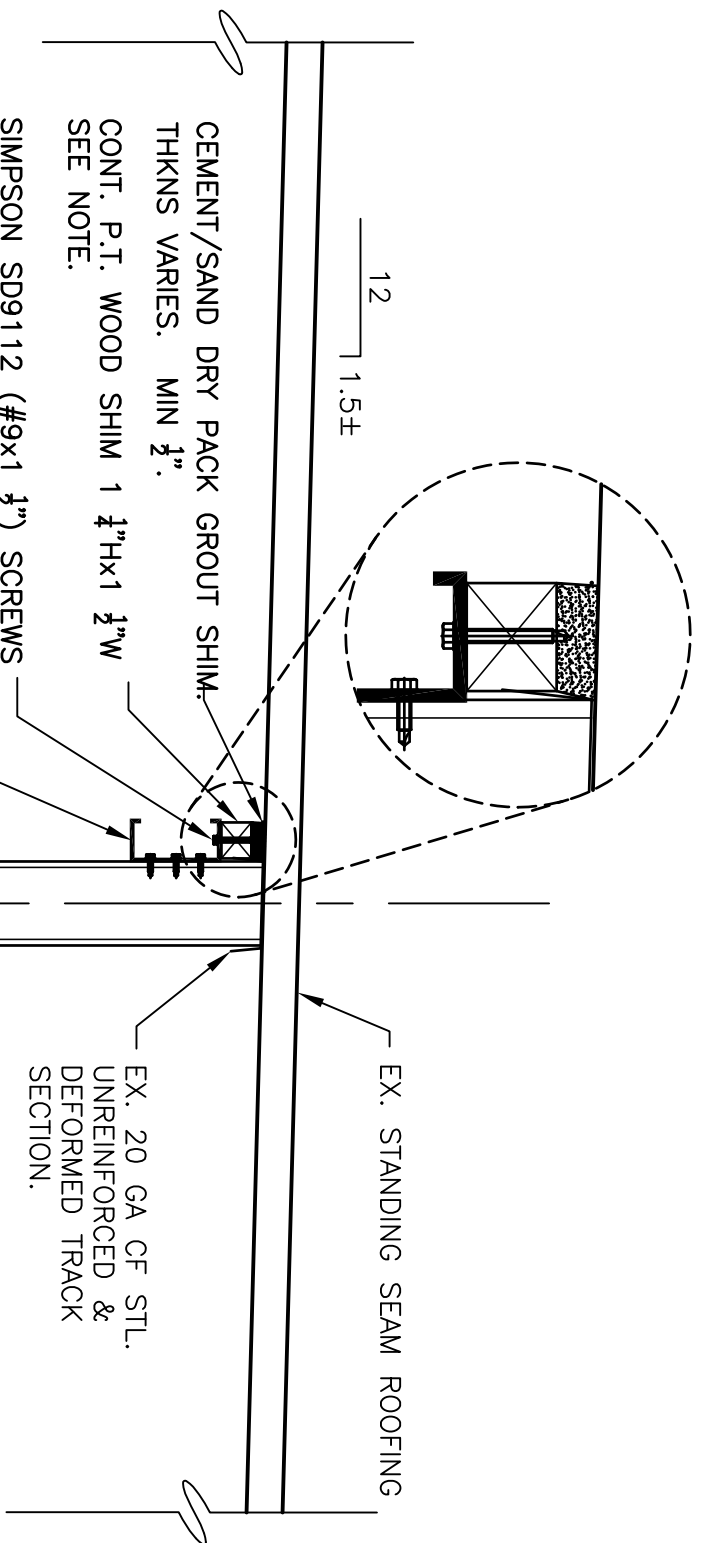
DETAIL
 1 1/2" = 1'-0"

EX. 20 GA CF STL.
 UNREINFORCED &
 DEFORMED TRACK
 SECTION.
 EX. 3 1/2"x20 GA. CF
 STEEL STUDS, 24" O/C

TYP. @ ALL ROWS OF
 CF STL STUDS WHERE
 TRACK IS UNREINFORCED
 AND DEFORMED.

I created and have attached several 8 ½ x 11 engineering sketches (SK's) to this report for reference. SK-1 and SK-2 are sections which depict the 1960 and 2004 roof framing systems, as they currently exist over the classroom wing. SK-3 shows the repair scheme described earlier in this report, but in more detail. I have not provided detailed material specifications etc., but could do so if you decide to move ahead with this scheme. As we discussed, I consider this scheme inelegant, but it will provide a structurally adequate repair. It should be noted that I investigated epoxy and other more high tech options for the variable thickness shim, but settled on the use of cementitious grout for cost and simplicity.

NOTE
 LOCATE NEW CF STL CSJ SECTION
 JUST UNDERNEATH LOW PTS. OF
 DEFORMED TRACK FLANGE TO ALLOW
 SUFFICIENT ROOM FOR P.T. WOOD
 SHIM AND MIN 1/2" NS GROUT.
 SD9112 SCREW TIPS HAVE MIN 1/4"
 CLEARANCE TO U'SIDE OF EX.
 ROOFING.

3 5/8" x 1 5/8" 20 GA CF STL CSJ
 SECTION 33 KSI FY. SCREW TO EA.
 EX. CF STL STUD W/ (3) #10 TEKS2
 SDST SCREWS. SEE NOTE

CEMENT/SAND DRY PACK GROUT SHIM.
 THKNS VARIES. MIN 1/2".
 CONT. P.T. WOOD SHIM 1 1/4"Hx1 1/2"W
 SEE NOTE.
 SIMPSON SD9112 (#9x1 1/2") SCREWS
 @ 8" O/C. PRE DRILL HOLES IN
 FLANGE OF NEW CSJ PRIOR TO
 INSTALLING. TIP OF SCREW PROTRUDES
 FROM PT WOOD SHIM TO HOLD GROUT
