Project No. 752019

February 4, 2020

Subject: Canaan Elementary School Roof

SSE 01/10/20 INSPECTION PHOTOS

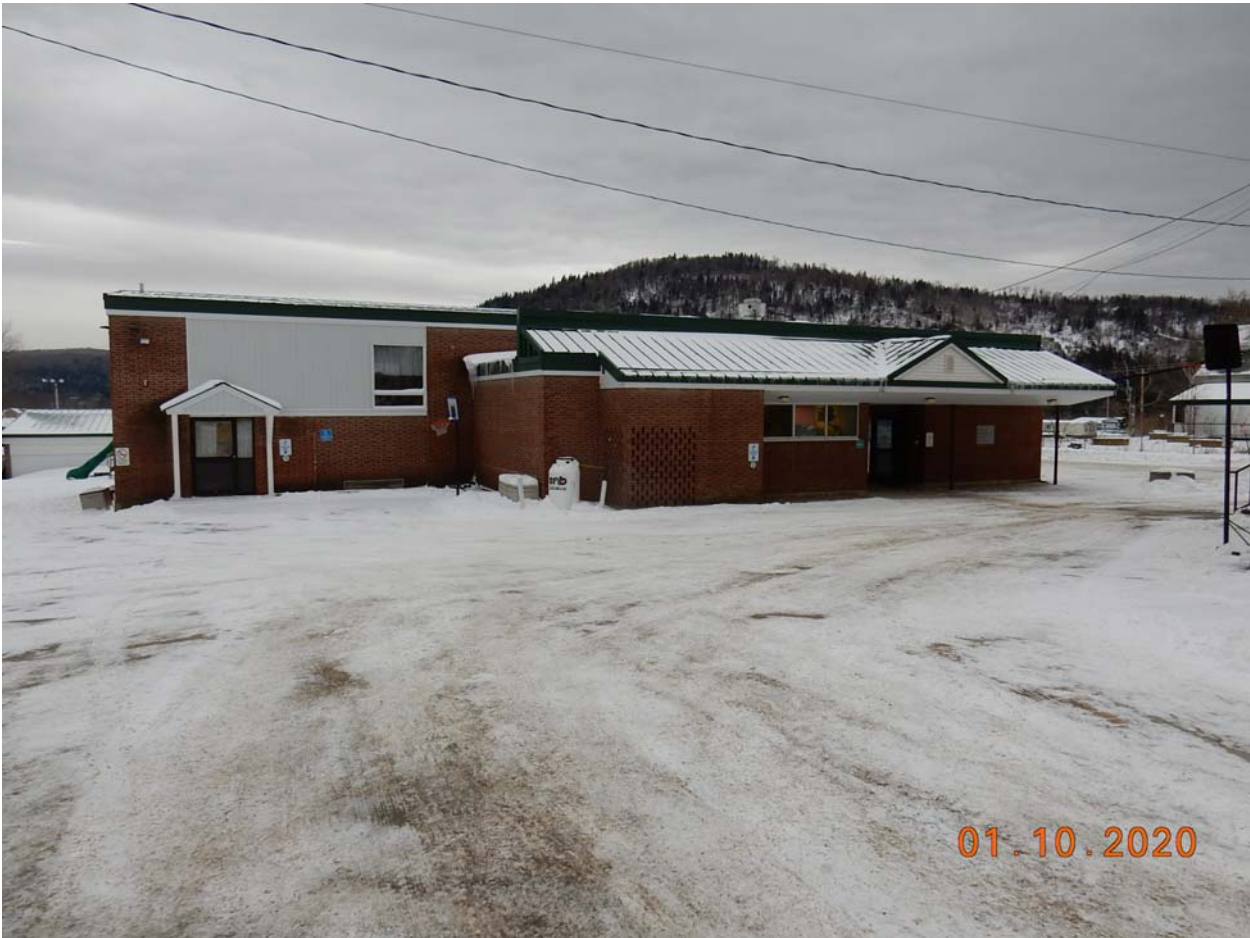
Looking south at the front of the school.

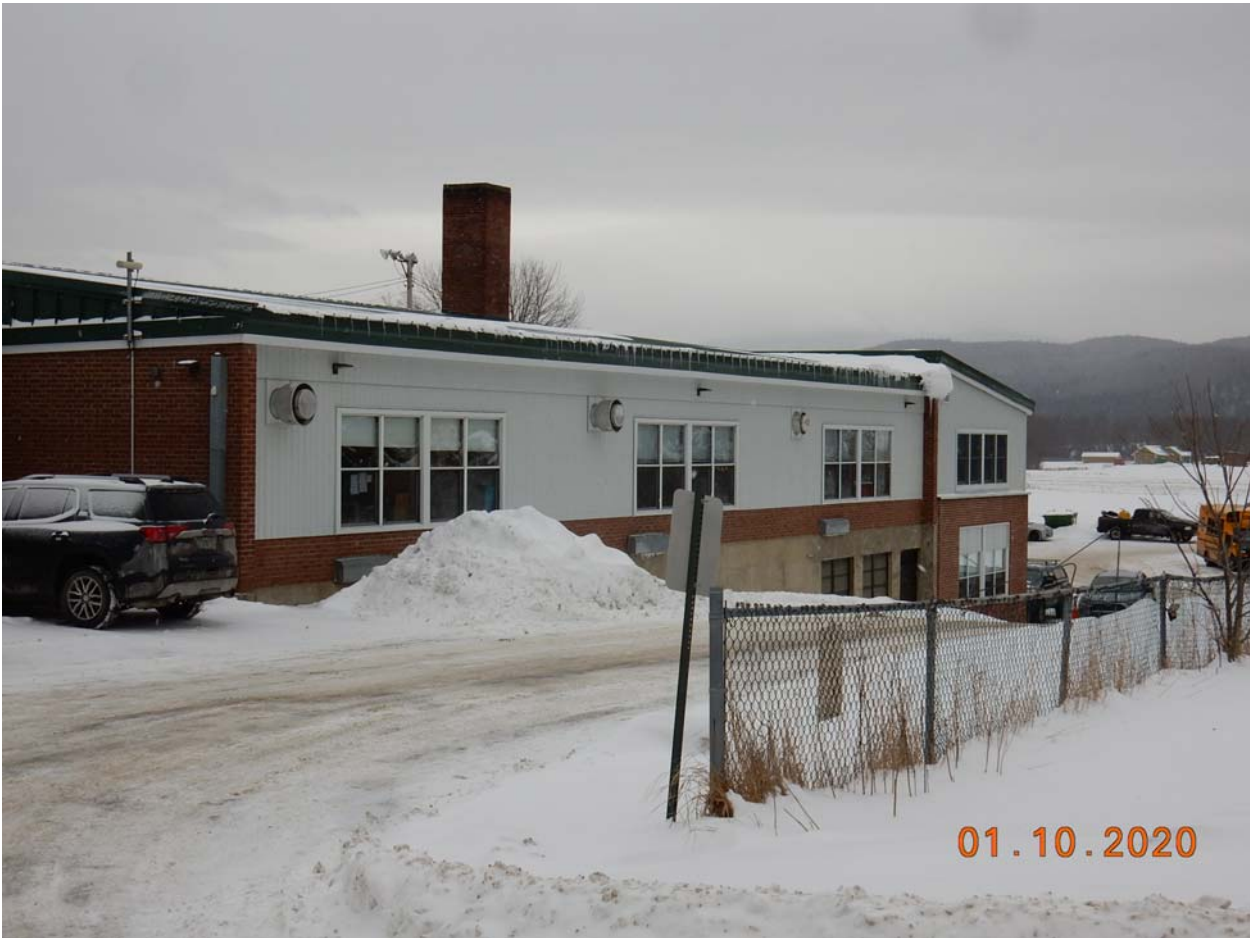
Looking southeast at the west side of the classroom wing.

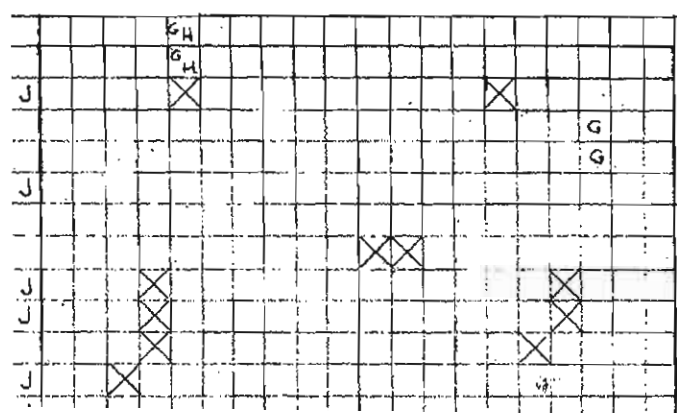
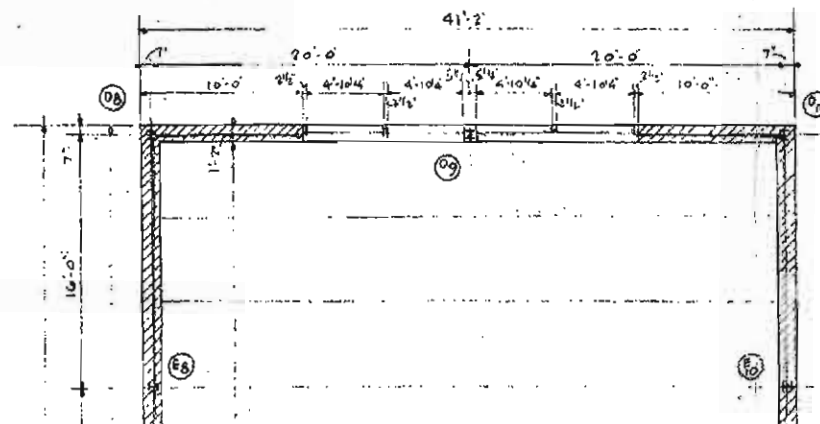
Upon inspection of the school's attic space above the classrooms, it was apparent that the 2004 roof modifications had significant problems in the southeast quadrant of that section of the building. In the southeast quadrant, I found that the rows of cold formed steel studs had only a track (also called a "runner") section at the top of the studs, and that those track sections had buckled flanges which were significantly deformed, with the tracks sagging by as much as $\frac{3}{4}$ " (estimated) between the studs. A very quick review of other nearby areas in the classroom attic revealed that the stud rows there had tracks that were reinforced with a strongback, an additional cold formed steel member. Where the reinforcement was present (reportedly the majority of the attic space above the classrooms), the tracks were not noticeably deformed or buckled. I have appended an excerpt from drawing # 2 of the 1960 architectural plans, showing the floor plan for the building. On that excerpt, I have hatched the currently known problematic area in pink, to identify its location. That area is about 36' wide east-west by about 50' long north-south. The area encompasses attic space from the current ridgeline eastward to the east eave, and from the south end of the classroom wing 50' northward to about the mid length of the wing.

PROBLEM AREA
 236' x 50'

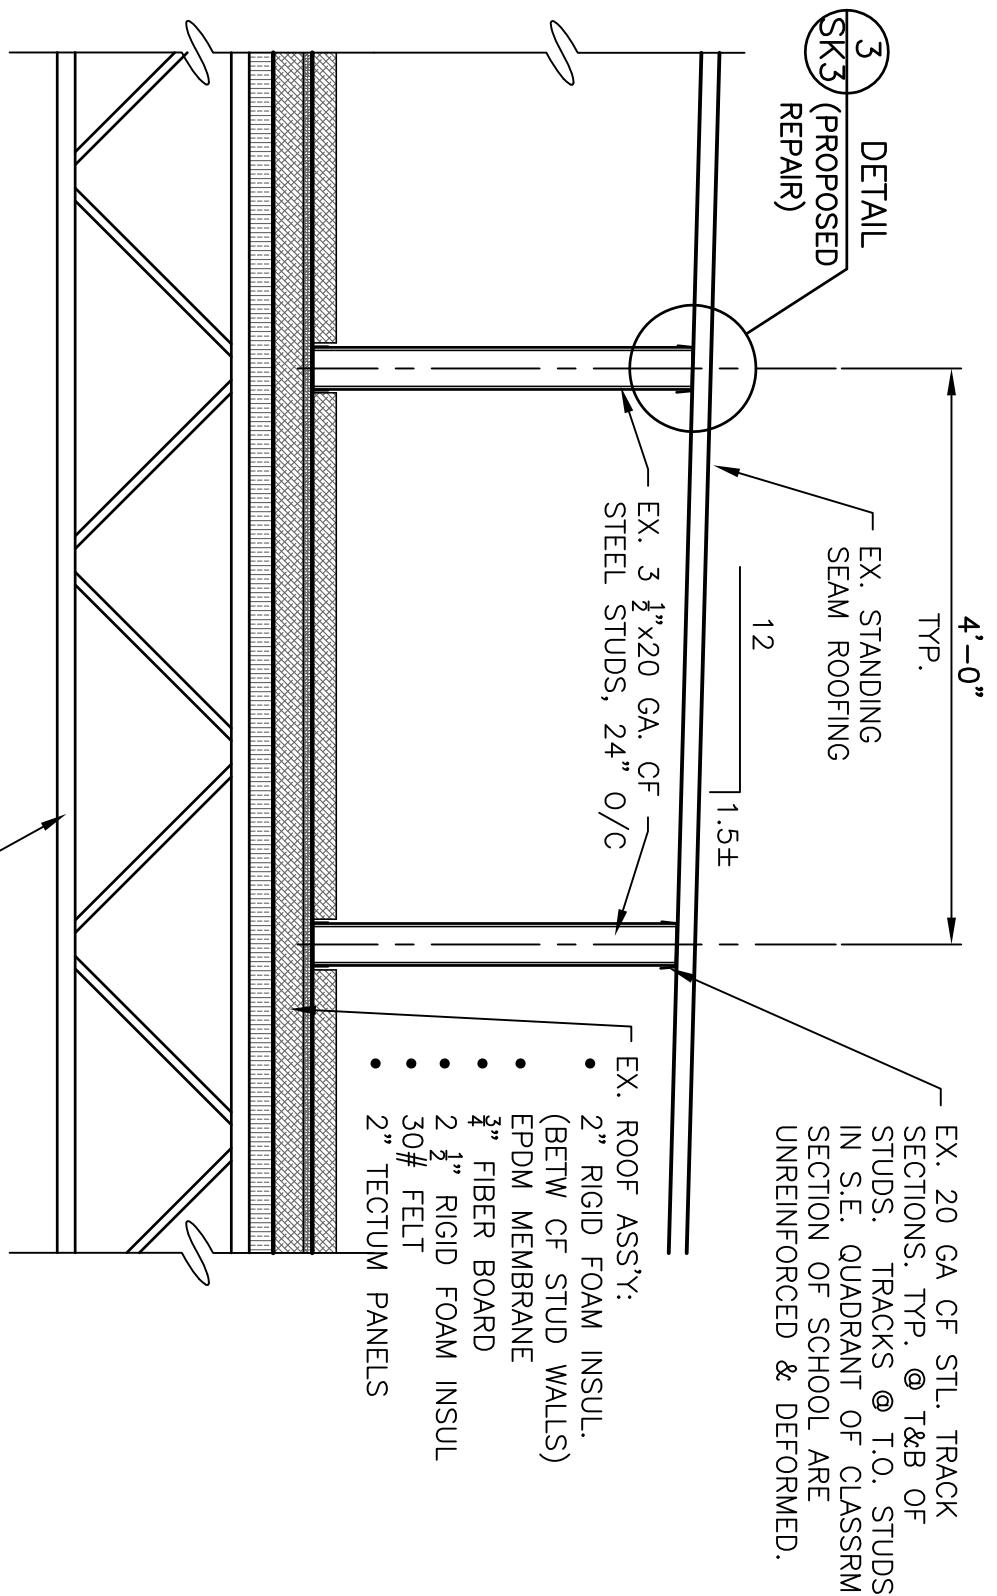
1 LOOKING NORTH

SECTION
3/4"=1'-0"

I created and have attached several 8 ½ x 11 engineering sketches (SK's) to this report for reference. SK-1 and SK-2 are sections which depict the 1960 and 2004 roof framing systems, as they currently exist over the classroom wing. SK-3 shows the repair scheme described earlier in this report, but in more detail. I have not provided detailed material specifications etc., but could do so if you decide to move ahead with this scheme. As we discussed, I consider this scheme inelegant, but it will provide a structurally adequate repair. It should be noted that I investigated epoxy and other more high tech options for the variable thickness shim, but settled on the use of cementitious grout for cost and simplicity.
